Attachment 4 - TABLE 3: Sub -Surface Structure Emissions

5 Interim Recommendations

Condition Assessment Tasks List

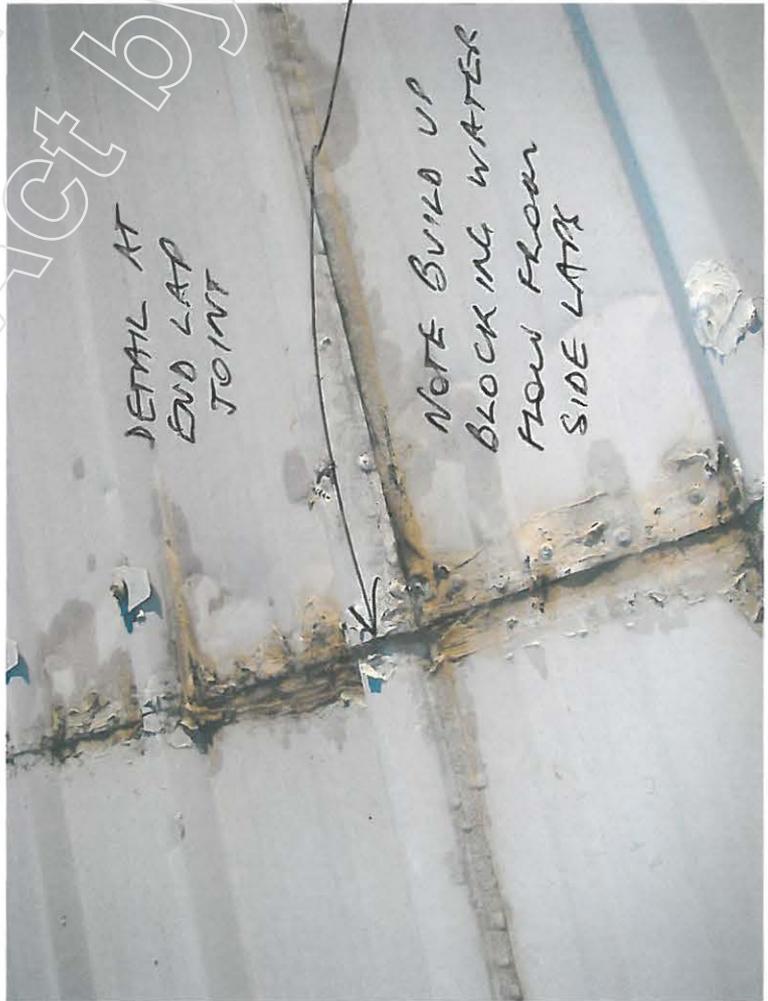
The roof sheeting remains in sound condition, but serious issues relate to the endlaps which have been partially sealed and water entry occurring over the sidelaps above these areas will accumulate at this point and track internally at the butt joints of the ceiling sheeting.

DETAIL AT
END LAP
JOINT

NOTE BUILD UP
BLOCKING WATER
FLOW FROM
SIDE LAP

- To an area approx. 3 lineal metres either side of the tables, clean the endlaps and sidelaps of the roof sheeting.
- Reseal the endlap correctly including removal of surplus sealant.
- Prime the sidelaps extending from the apron flashing at the top of the roof to approx. 2 lineal metres beyond the leaks over the tables.
- Apply DUROMASTIC AC membrane including fibreglass reinforcement over all laps within the area in question.
- The membrane system will be built up with three additional coats of DUROMASTIC AC to provide an elastic barrier able to withstand repeated cycles of movement.
- As both the sidelaps and the endlap in question within the area referred to will be sealed in this manner, water entry would be prevented.

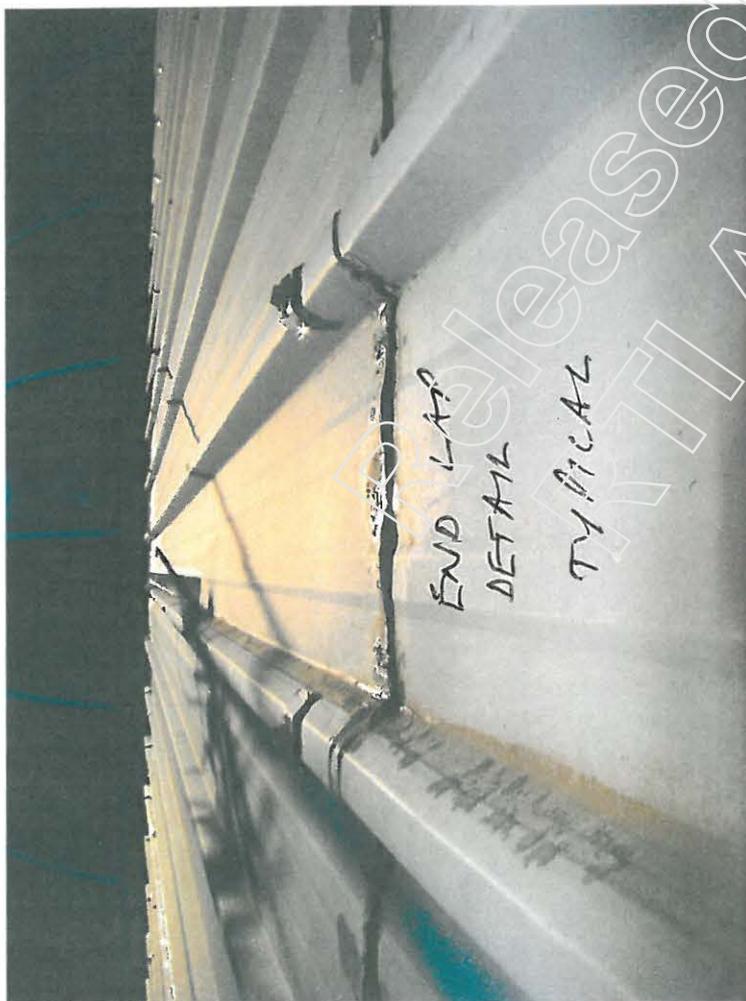
The reported water entry is occurring in a line along the butt joint of the ceiling sheeting and this equates to a similar situation to that of the Dining Hall where the end lap has been partially sealed, but the sidelaps left open, indicating that moisture exceeding the sidelaps and being unable to exit at the endlaps due to being sealed, it builds up and enters internally.

END LAP?
DETAIL
TYPICAL

- To the roof area over the reported leaks only, prime the sidelaps extending from the top of the roof to approx. 3 lineal metres beyond the overlap joint.
- Clean surplus sealant from the overlap joint and ensure the sheeting is pinned correctly.
- Seal all overlaps and endlap in question with the DUROMASTIC AC membrane system including fibreglass reinforcement and three coats of membrane as previously specified.

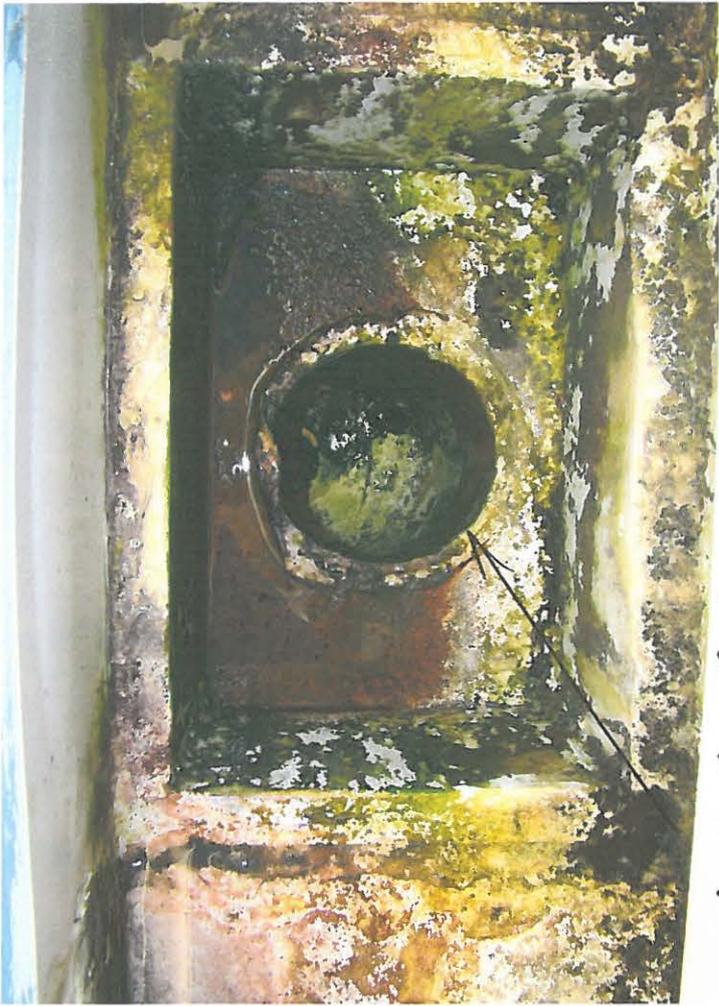
TYPICAL SUMP DETAIL

The box gutter itself although in sound condition structurally, is affected by light to heavy rust in isolated areas and although not contributing to the immediate issues, if left unattended in this manner will finally rot out.

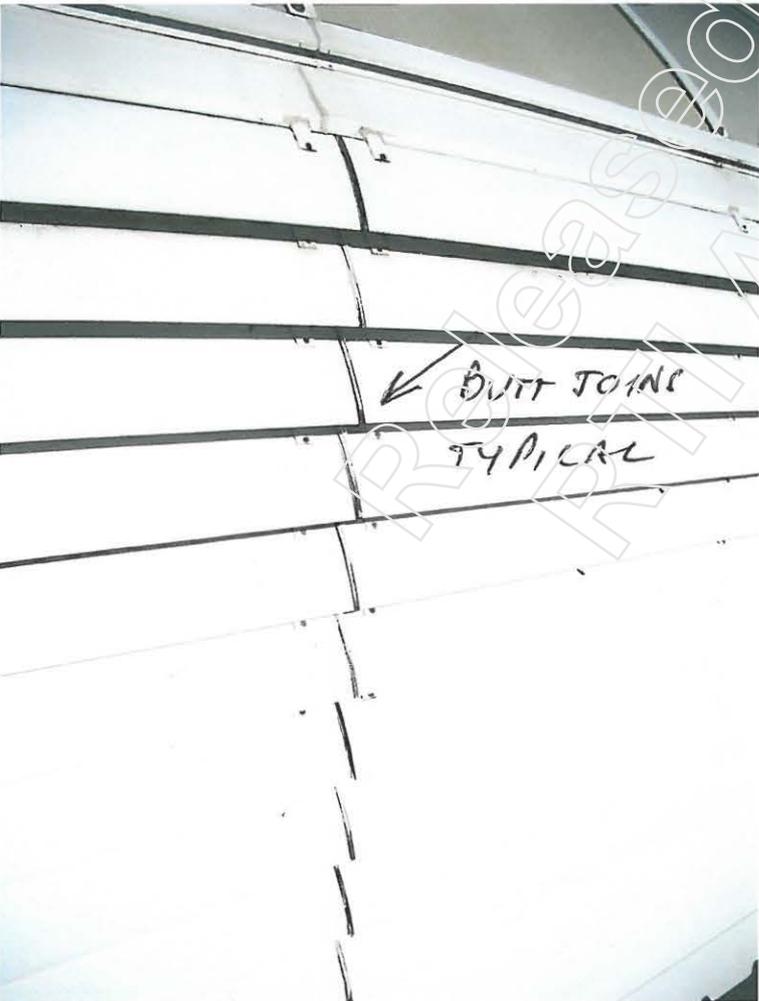
Where the louvered butt joints occur, the previously installed foam or sealant has failed or weathered and although generally not a contributor to the current situation may become so if left in this manner.

BUTT JOINS
TYPICAL

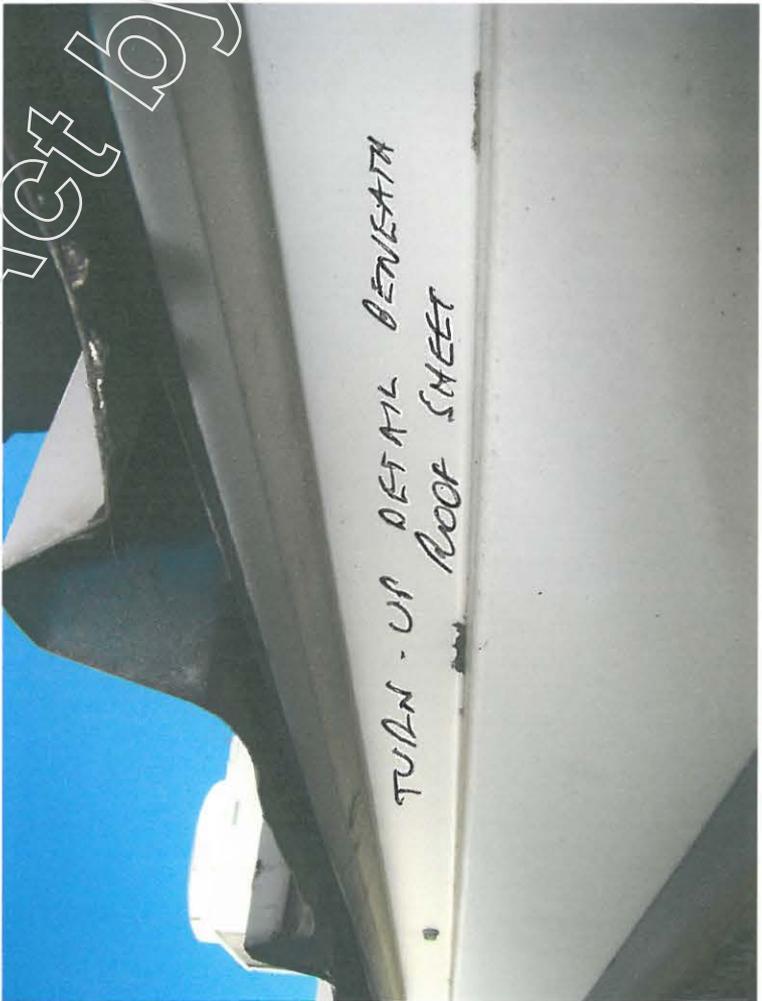
At the junction of the box gutter and the louvered wall, what appears to be a galvanised flashing detail is installed. The flashing on the horizontal section falls back from the box gutter toward the internal areas and it appears that the overlap joints have never been sealed correctly or if previously sealed, the sealant has failed.

TURN-UP DETAIL BENEATH
ROOF SHEET

- The above flashing detail will ensure that moisture which reaches the angle is discharged toward the box gutter rather than accumulate on the horizontal section of the angle as presently occurring.
