Runaway Bay Sports Super Centre

Pool Refurbishment and Sports Medicine Roof Replacement

April 2014

Runaway Bay Sports Centre
Pool refurbishment and Sports Medicine roof replacement
Scope of Works

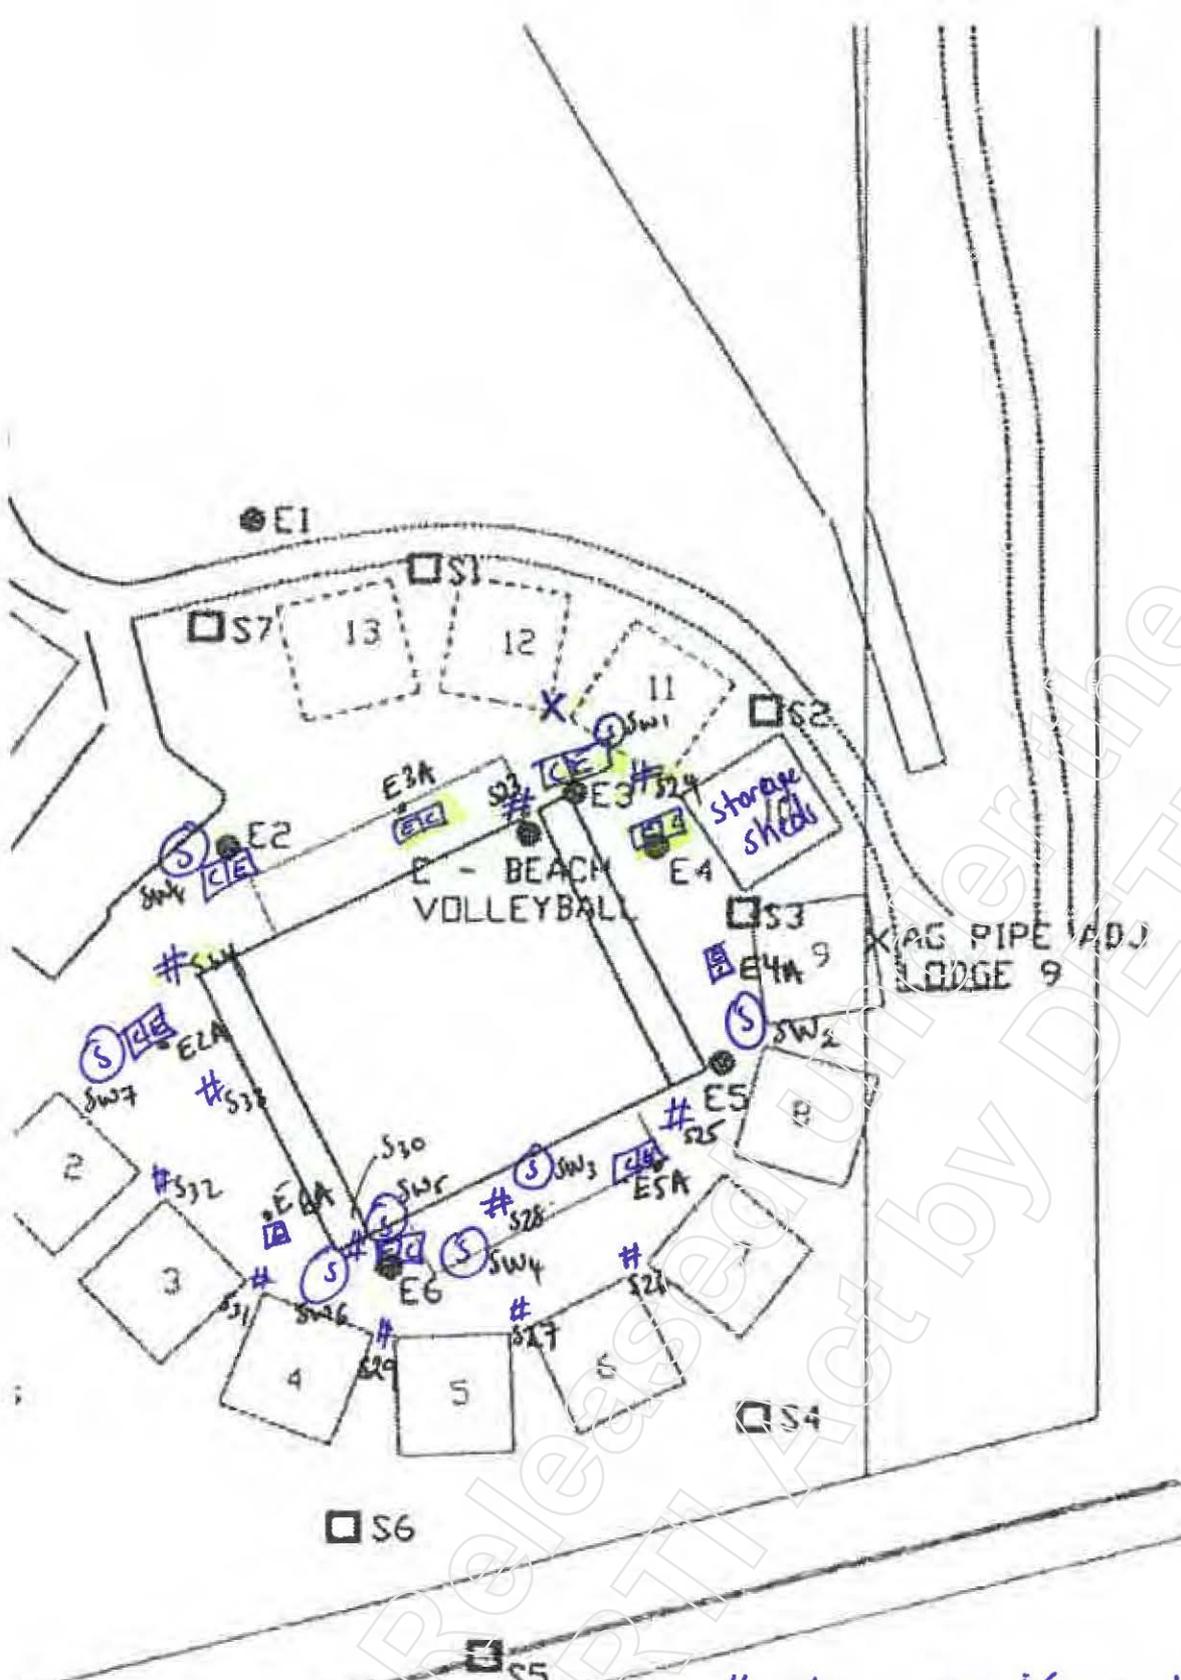
Attachment 2: Site sketch of additional service pits monitored

Methane levels of 5000 ppm and 2000 ppm were detected at these respective additional locations. These locations were not previously included in the monitoring program, however are recommended to be included in future visits (and have been assigned as monitoring locations E9A and E10A for the northern and southern pits respectively).

1. Biannual monitoring (as a minimum) be scheduled at the selected locations detailed above to continue assessing trends in gas conditions for the site. A full assessment (monitoring of all site locations) is recommended on an annual basis (with the next monitoring round to be undertaken in June 2010).
2. Additional monitoring locations E9A and E10A (electrical pits on the northern and southern edges of the running track towards the scoreboard end) be included in future partial and full gas assessments at the site.
3. Storerooms 1 and 2 continue to be regularly opened to allow any potential methane build up to dissipate.
